PARATRANSIT VEHICLE TEST AND EVALUATION

Volume I: Ride Comfort and Quality Tests

1. Report No. UMTA-MA-06-0041-77-10	2. Government Accession No.	3. Recipient's Catalog No.	
4. Title and Subtitle LORAN AUTOMATIC VEHICLE MONITORING SYSTEM, PHASE I Volume I: Test Results		5. Report Date August 1977

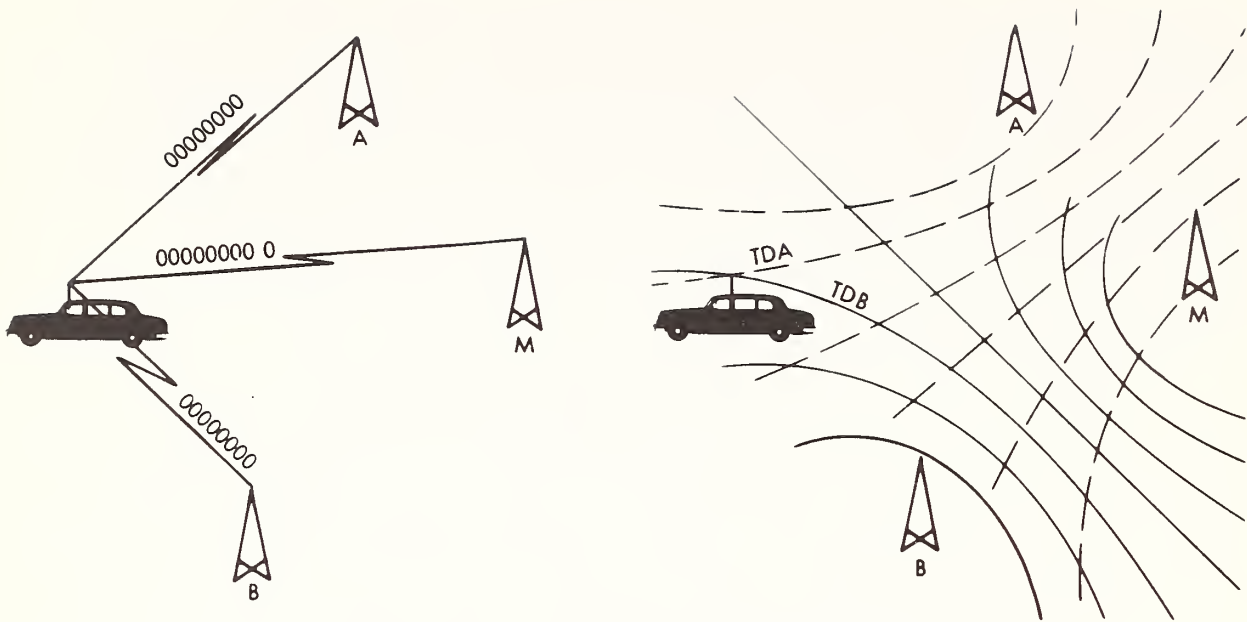
Figure 1-1. Hyperbolic Fix Geometry

These navigation systems operate on the principle that the difference in time of arrival of signals from two stations, observed at a point in the coverage area, is a measure of the difference in distance from the point of observation to each of the stations (See Figures 1-1 and 1-2). The locus of all points having the same observed difference in distance to a pair of stations is a hyperbola, called a line of position (LOP). The intersection of two or more LOP's defines the position of the observer. The accuracy of any hyperbolic navigation system depends on the observer's ability to measure the difference between the times of arrival of two signals (time difference, or TD), and his knowledge of the propagation conditions, so that the time difference can be converted to LOPs.

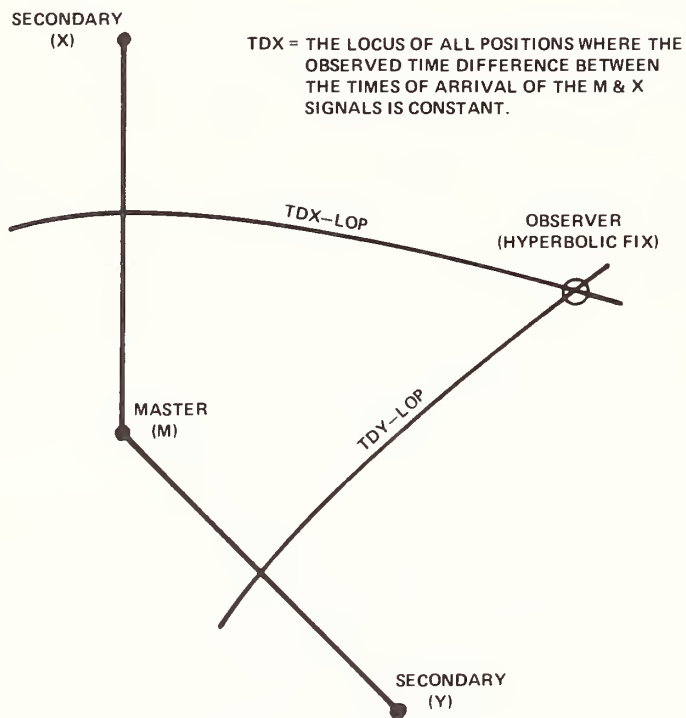
Figure 1-2. Time Difference Location Fix

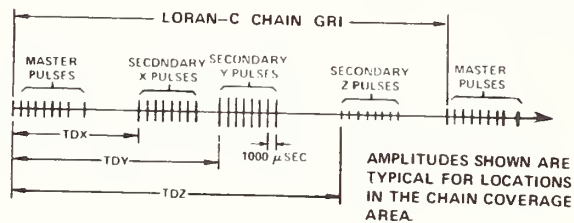
Figure 1-4. LORAN-C Chain GRI

or more stations cannot overlap in time anywhere in the coverage area. (See Figure 1-4.) Thus, with respect to the time of arrival of the master, a secondary station will delay its own transmissions for a specified time, called the secondary coding delay. The minimum GRI is therefore a direct function of the number of stations and the distance between them. A GRI for the chain is then selected so that adjacent chains do not cause mutual (cross-rate) interference. The GRI is defined to begin coincident with the start of the first pulse of the master group.

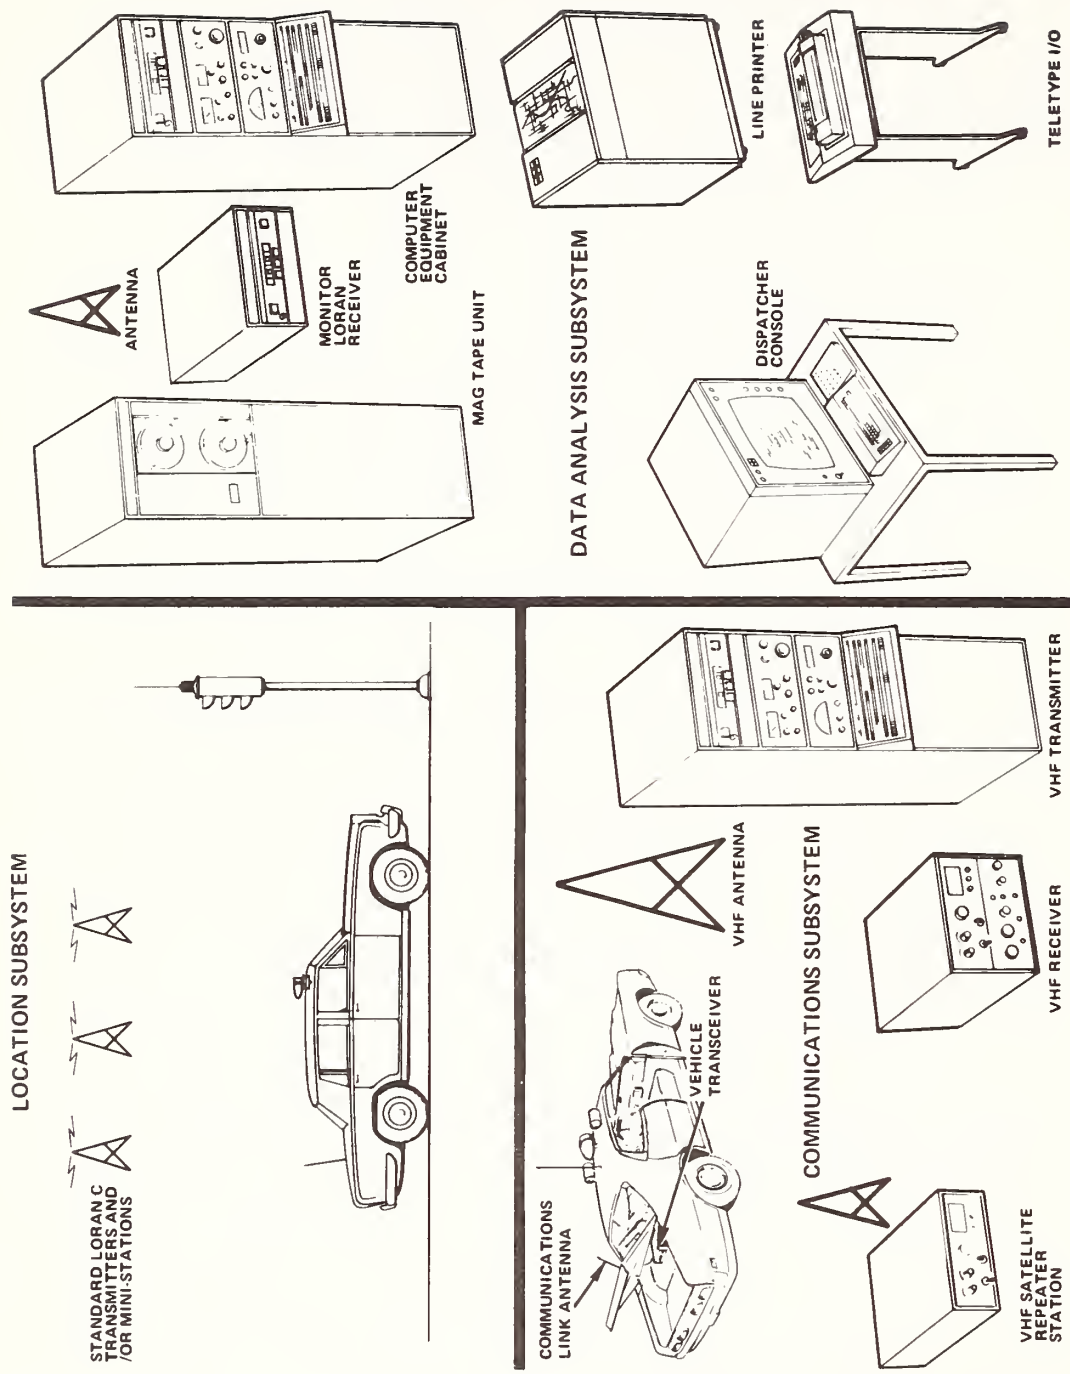
Figure 1-5. LORAN AVM System Components

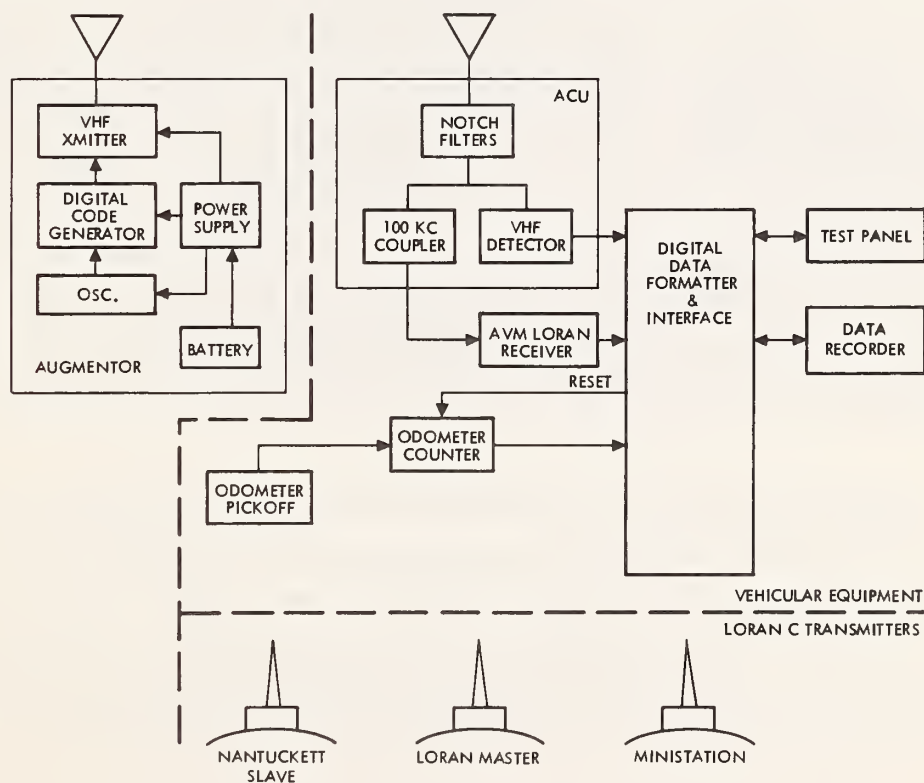
Figure 1-6. Location Subsystem

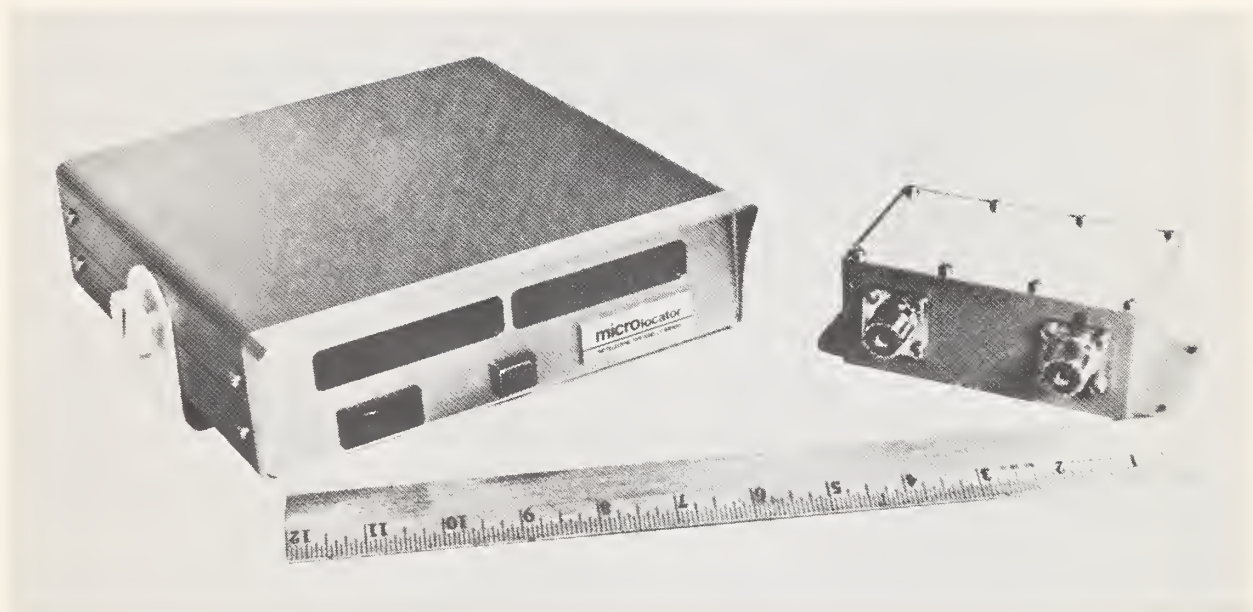
Figure 1-7. LORAN AVM Receiver

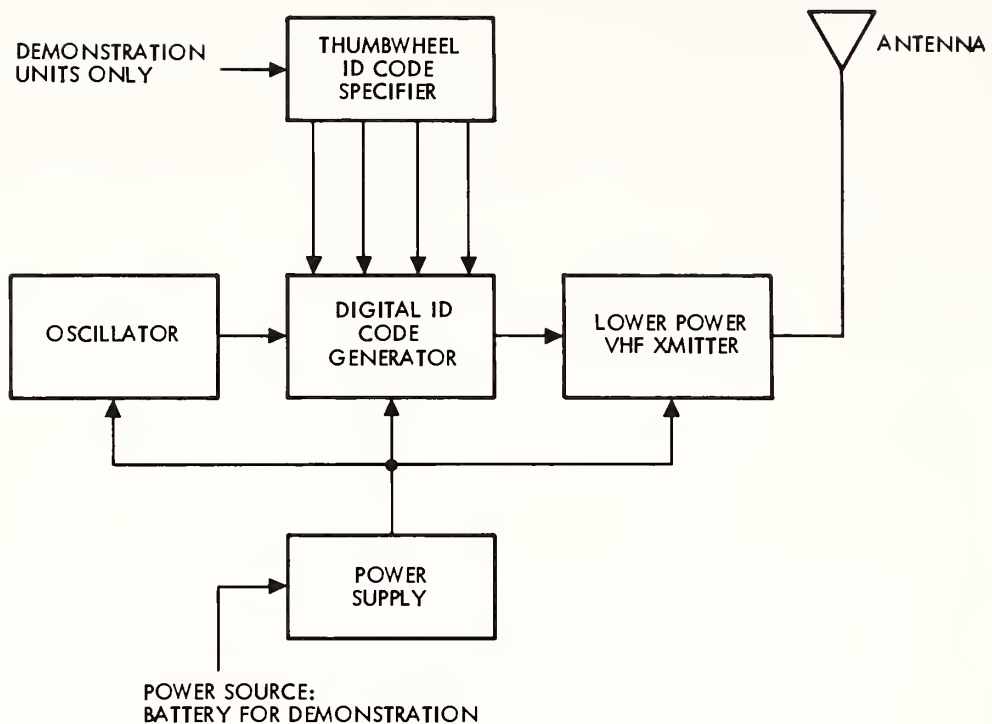
Figure 1-8. Block Diagram of Augmentor

1.3.1.3 Augmentor Device - The augmentor device which was demonstrated in Philadelphia was identical in function and operation to the production device for Phase II. A block diagram of the device is shown in Figure 1-8. The VHF transmitter is a low power, short range device. The remainder of the components are self explanatory except that the code specified in the code generator is in the

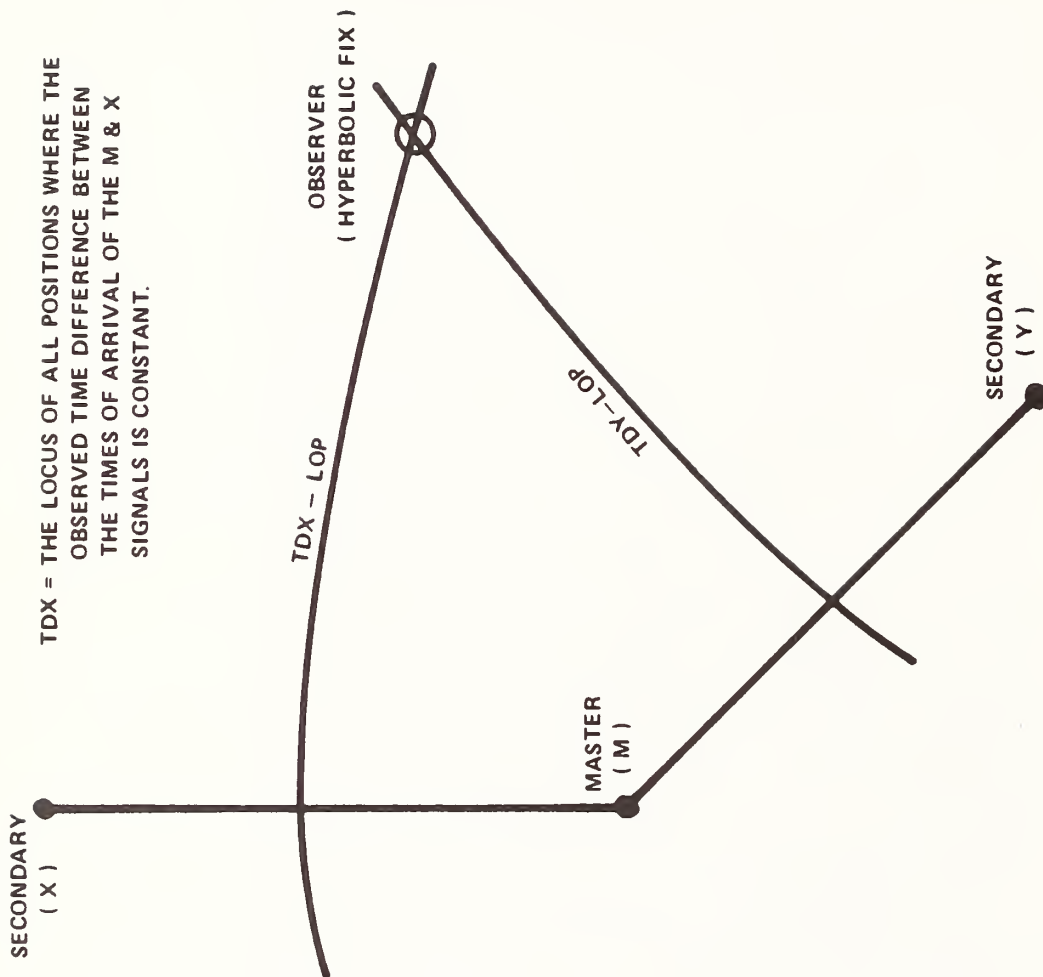
Figure 2-2. Hyperbolic Fix Geometry

Hyperbolic radio aids-to-navigation operate on the principle that the difference of time of arrival of signals from two stations, observed at a point in the coverage area, is a measure of the difference in distance from the point of observation to each of the stations (see Figure 2-2). The locus of all points having the same observed difference in distance to a pair of stations is a hyperbola and is a line of position (LOP). The intersection of two or more LOP's defines the position of the observer. The accuracy of hyperbolic radio aids-to-navigation depends on the observer's ability to measure the difference between the times of arrival of two signals (time difference or TD) and his knowledge of the propagation conditions so that the time differences can be converted to LOP's.

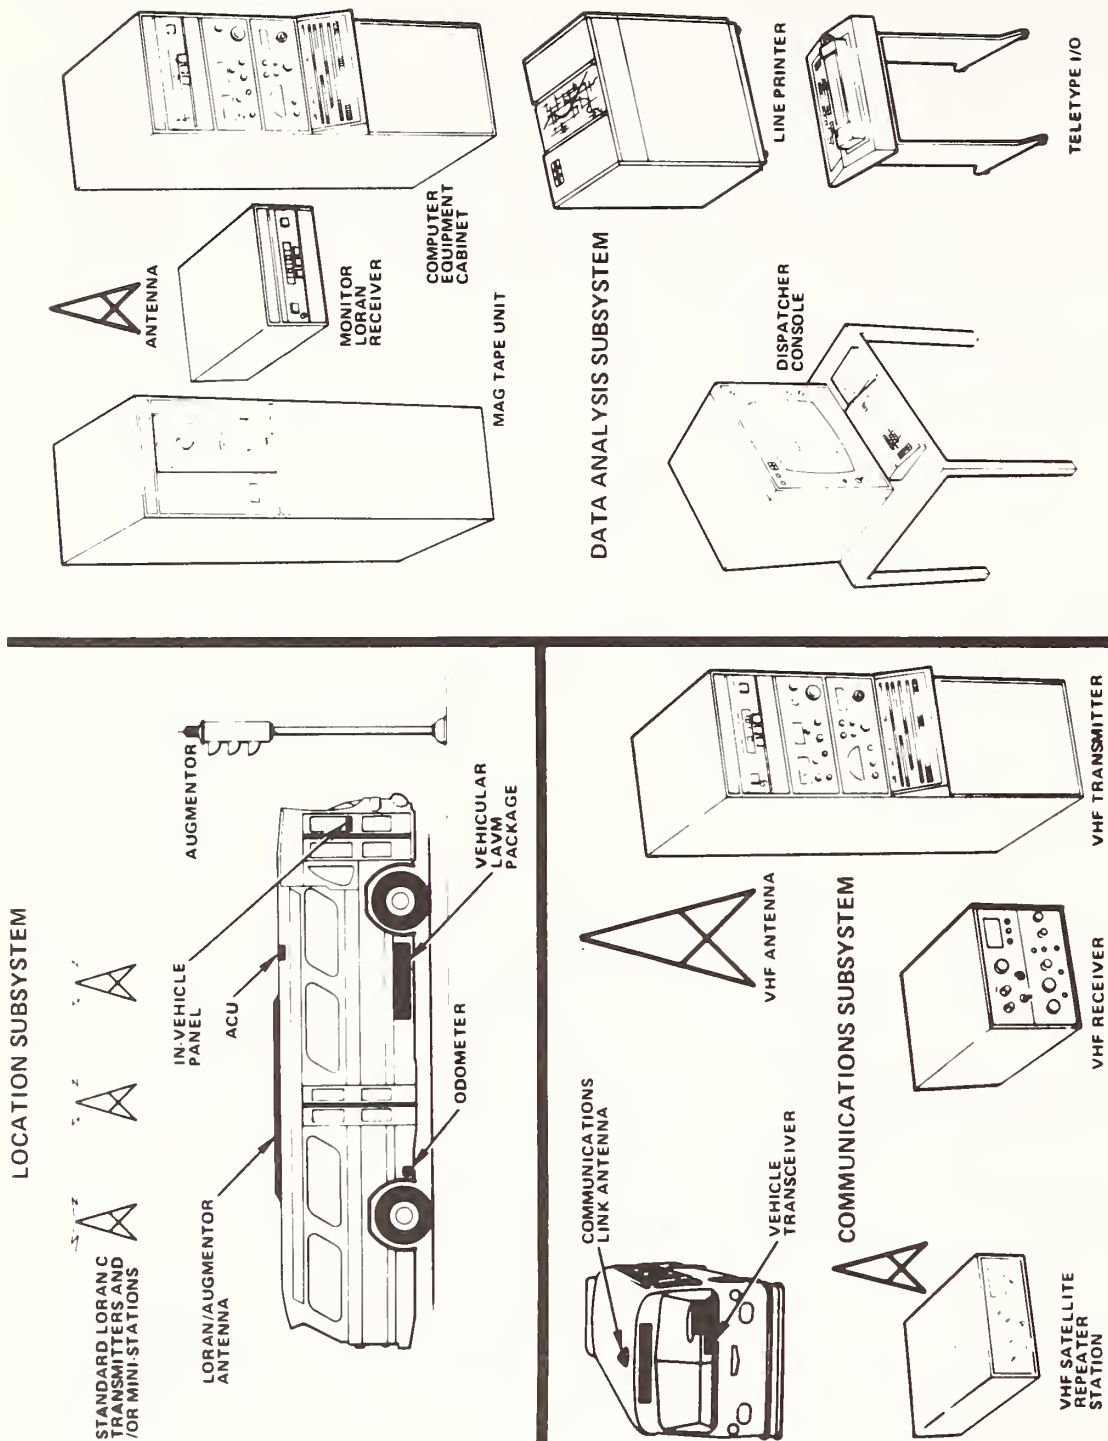
Figure 2-4. LAVM System

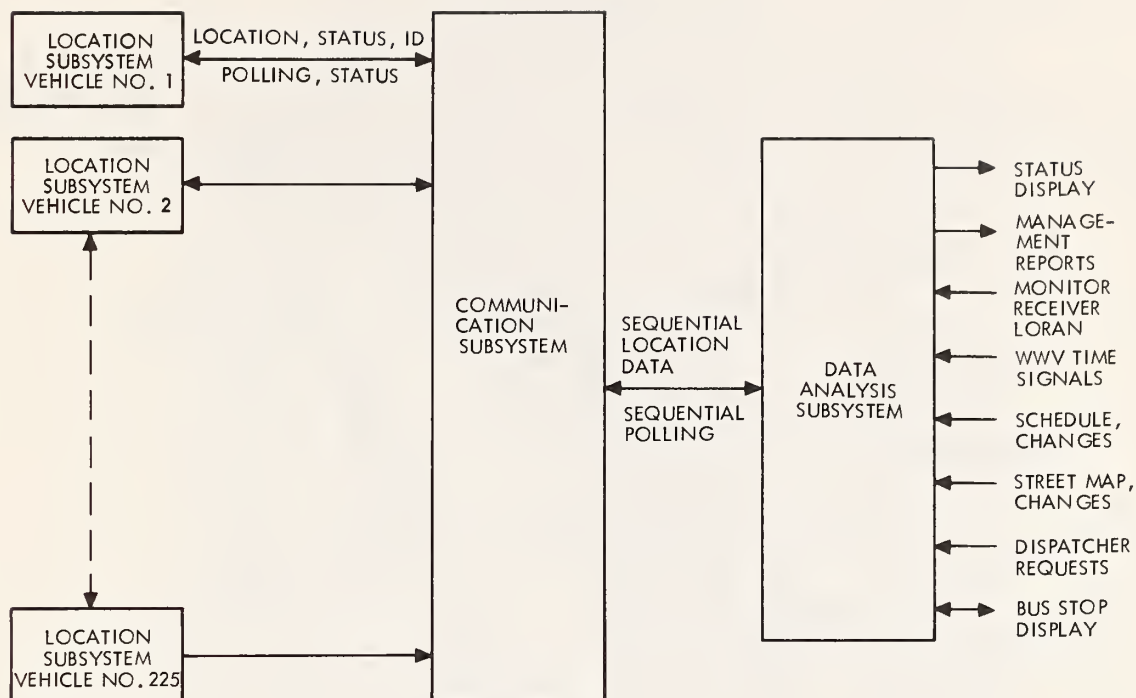
Figure 2-5. System Interface Diagram

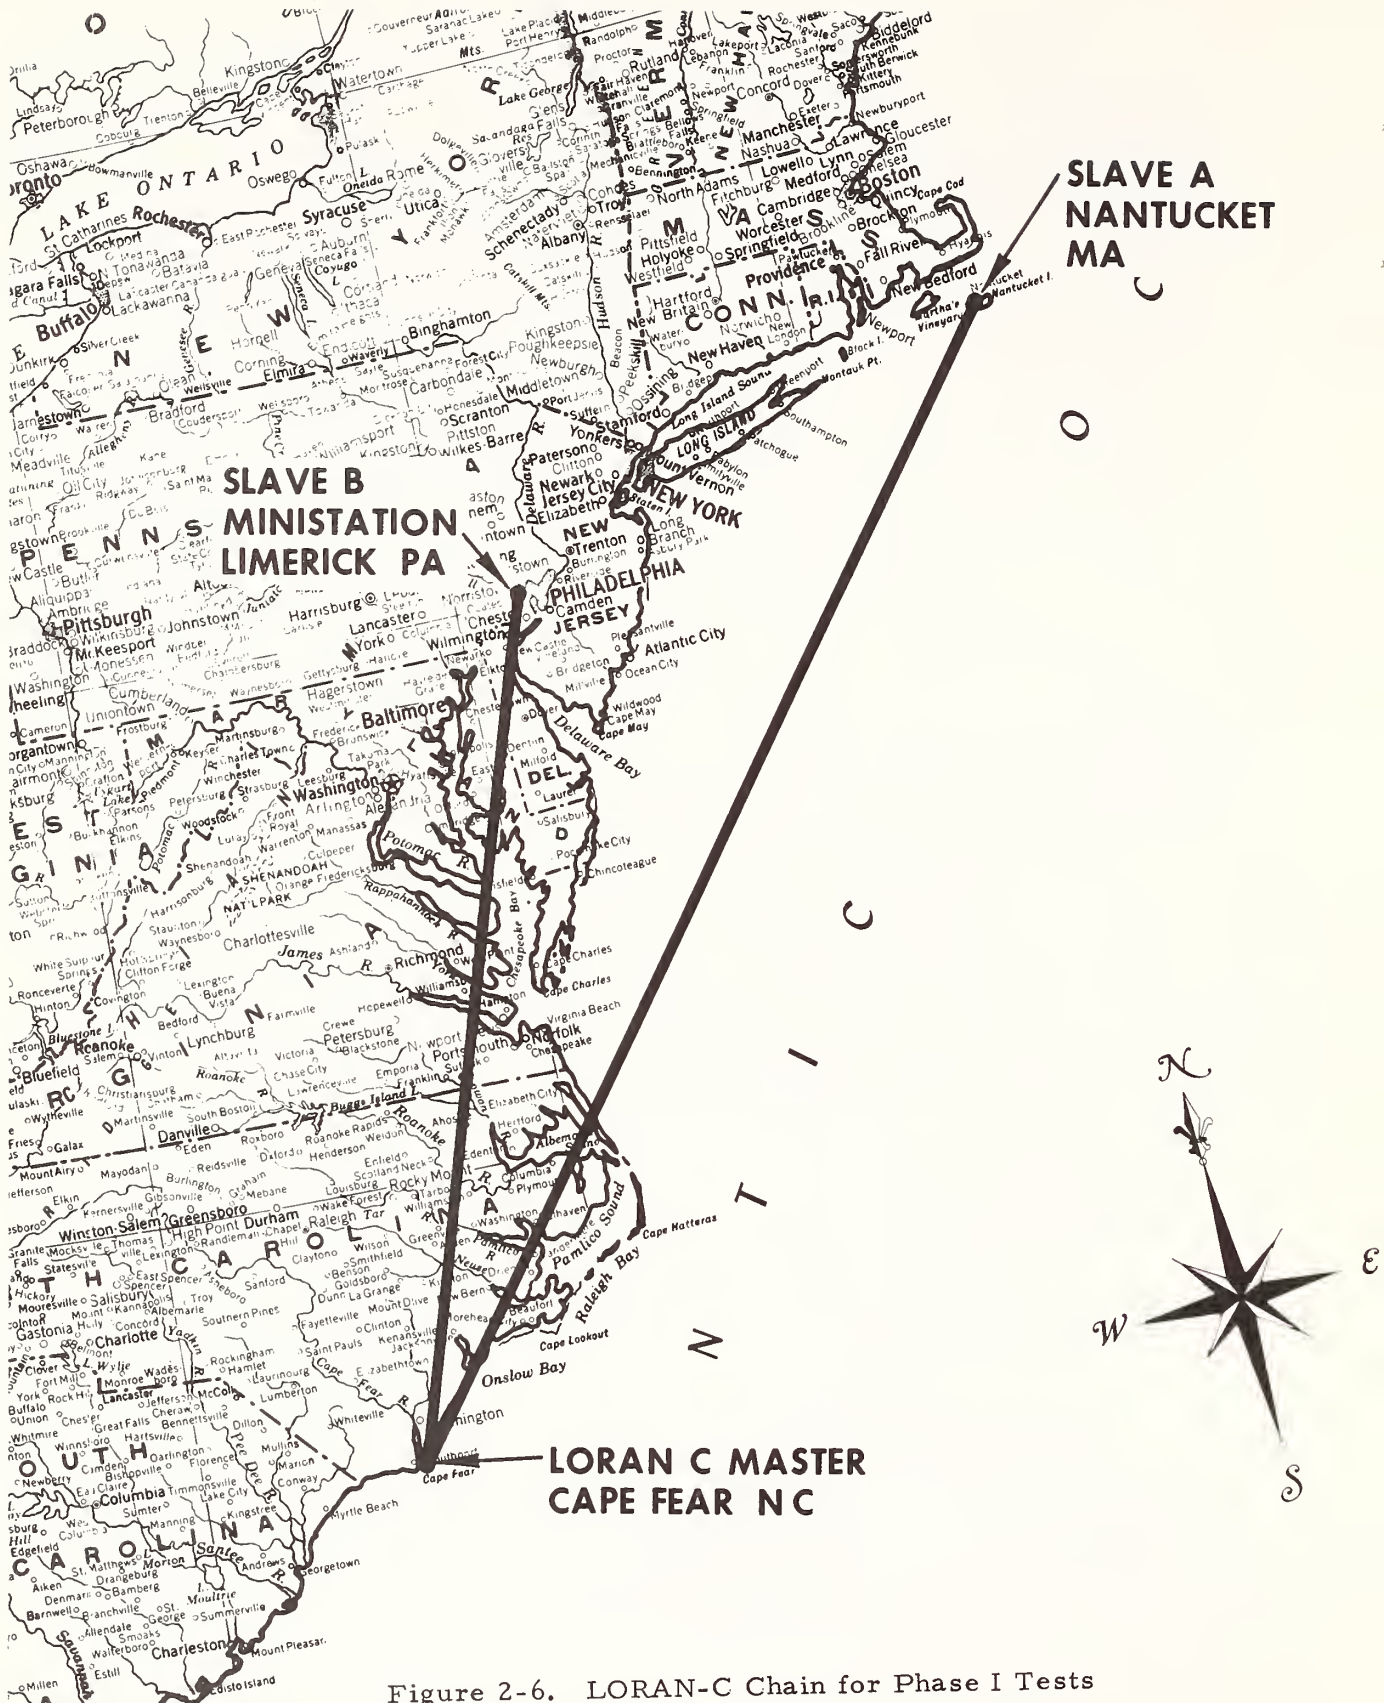
Figure 2-6. LORAN-C Chain for Phase I Tests

The LORAN chain used for all testing was the U.S. East Coast Chain (SS-7) augmented by a temporary ministration which was utilized as the B slave. This

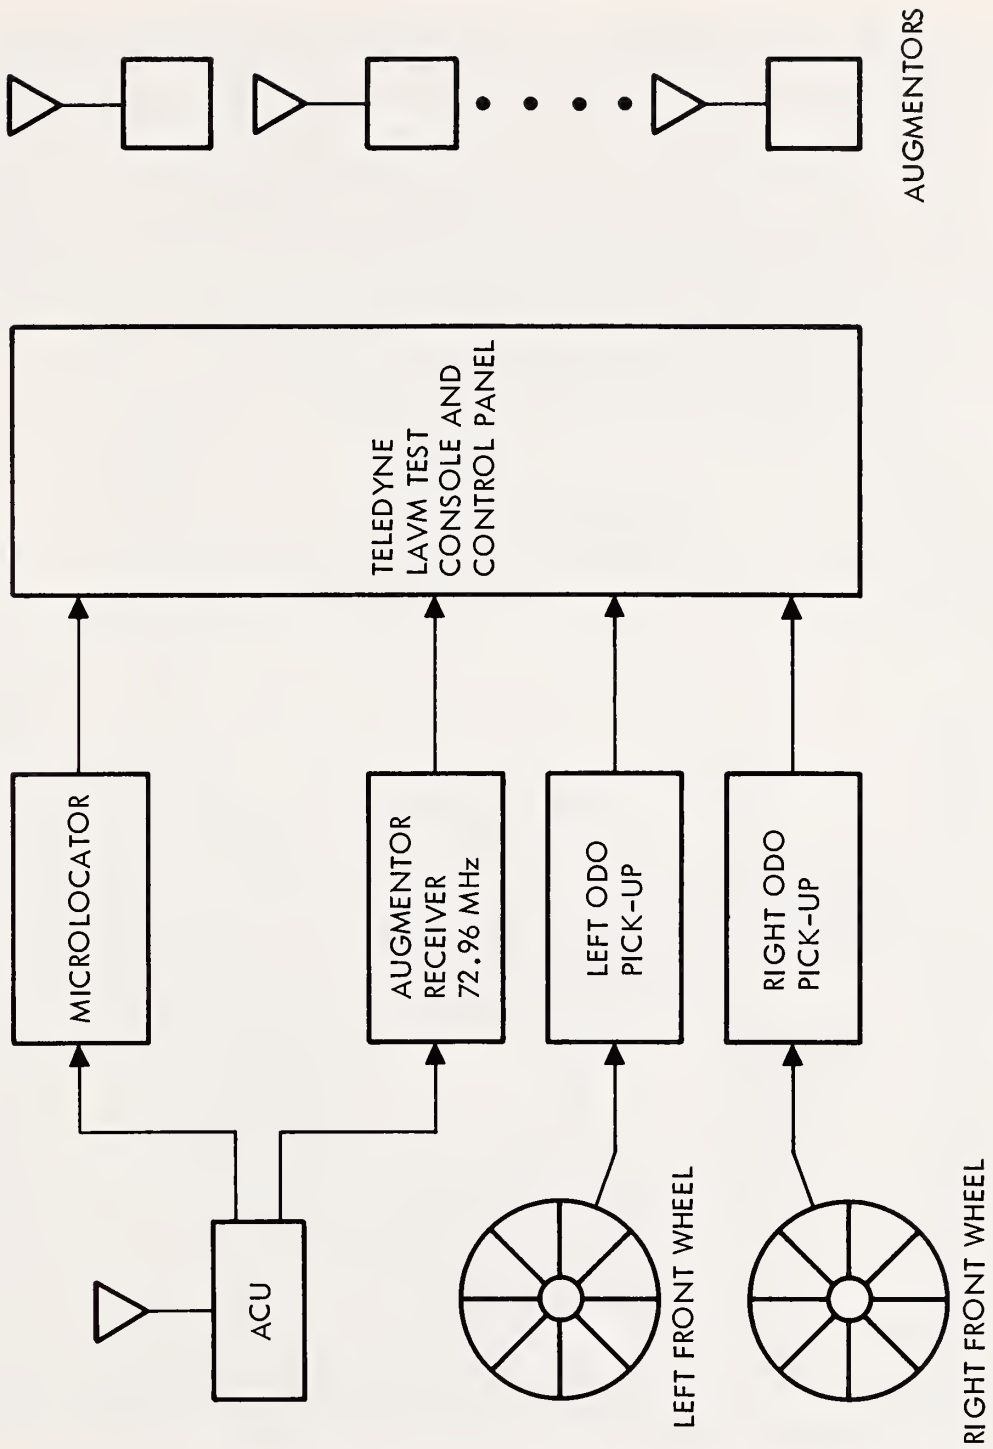
Figure 3-1. Block Diagram - LAVM Equipment

3.2.1.3 Left, Right Odometer Pickup - The odometers are hall effect proximity sensors permanently installed on the test vehicle. One device was installed near each front wheel. They sense proximity to 10 magnets which were installed on the inside of each wheel. Wheel rotation causes outputs which can be counted in the LAVM equipment and used to determine distance traveled.

3.2.1.4 Augmentor Receiver - The augmentor receiver is a circuit for detecting and demodulating the 72.96 MHz signal generated by the augmentor.

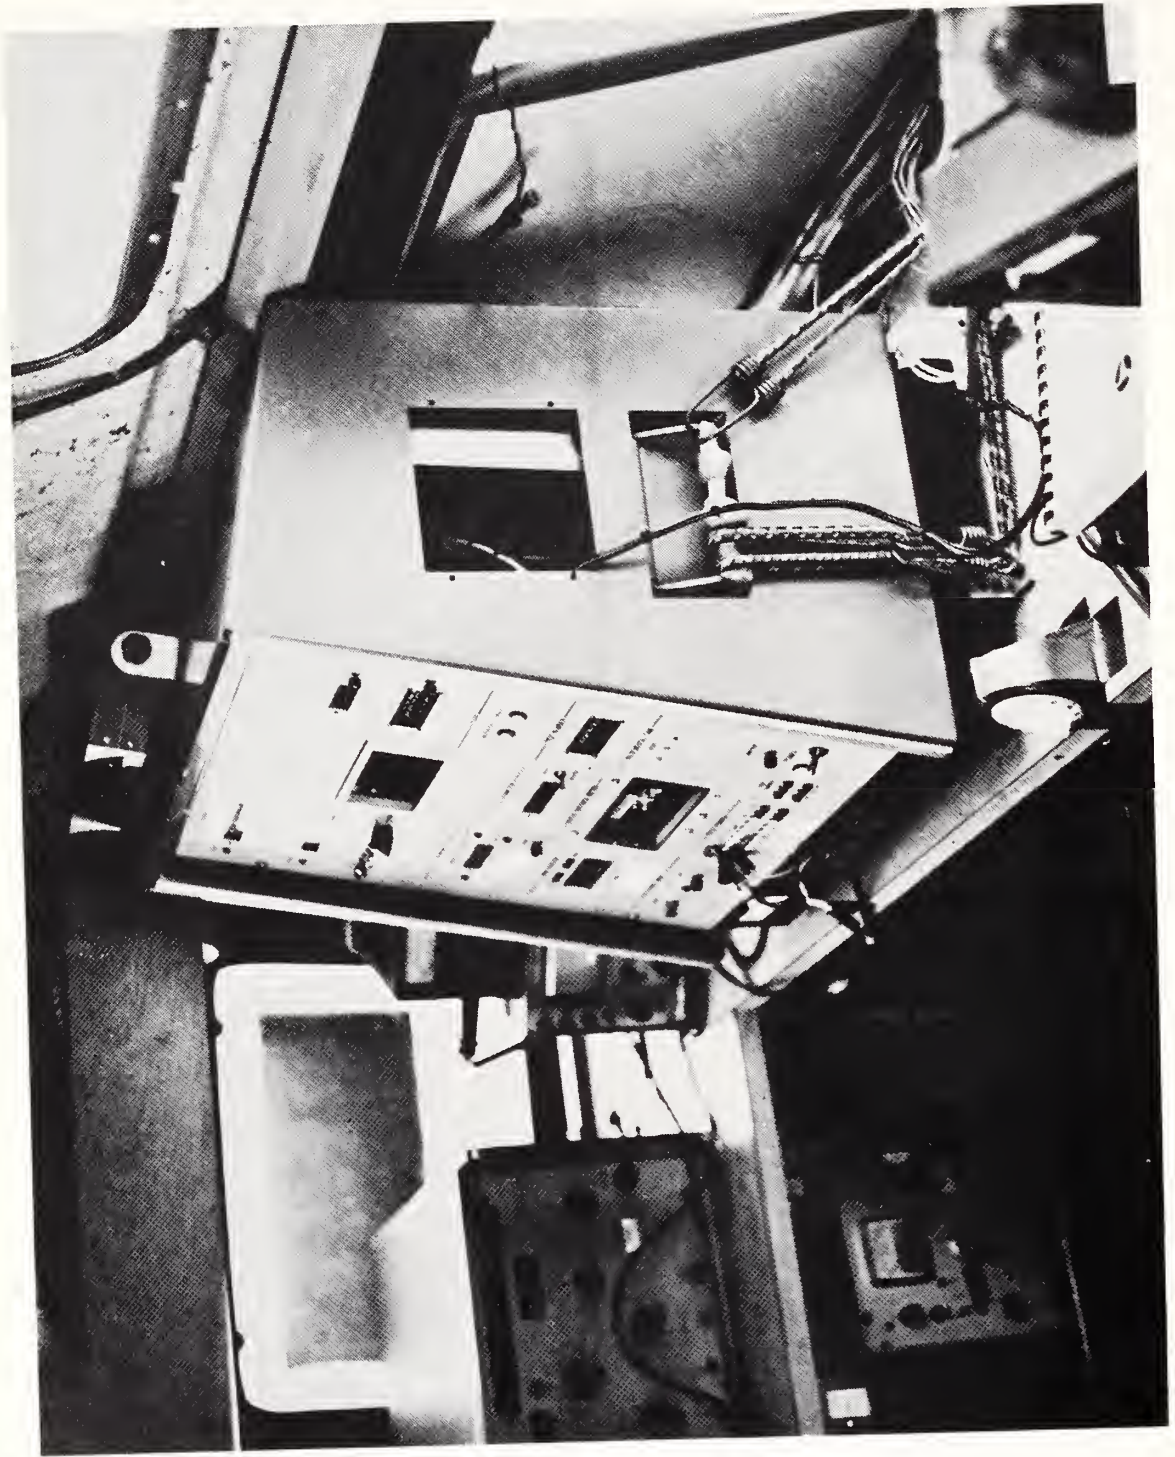
Figure 3-2. Micro-Locator LORAN Receiver and Test Console

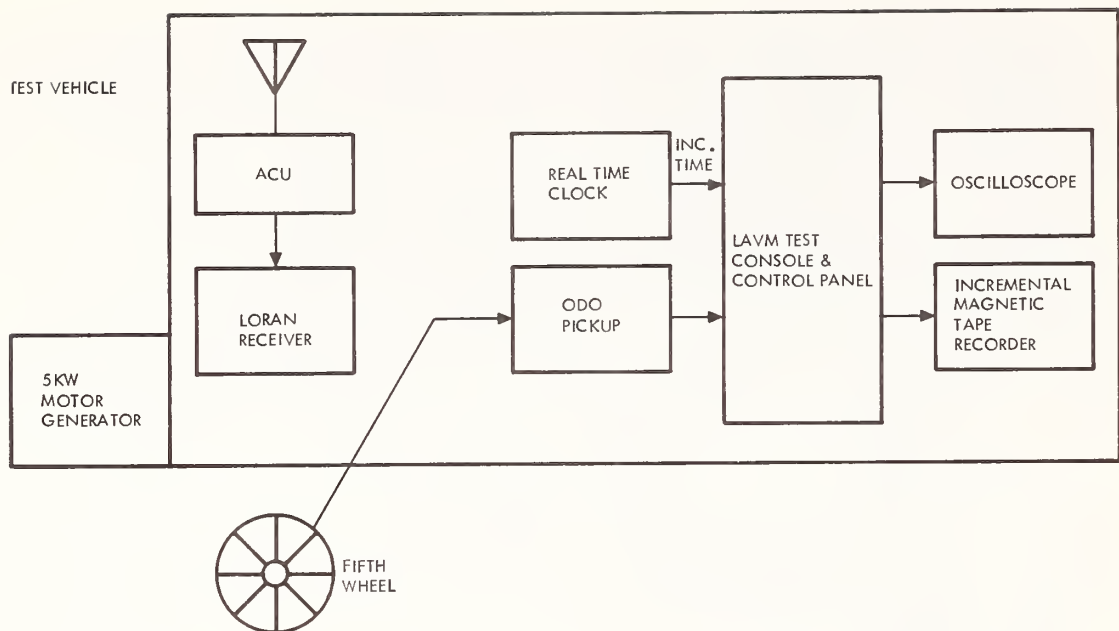
Figure 3-4. Test Instrumentation Equipment Block Diagram

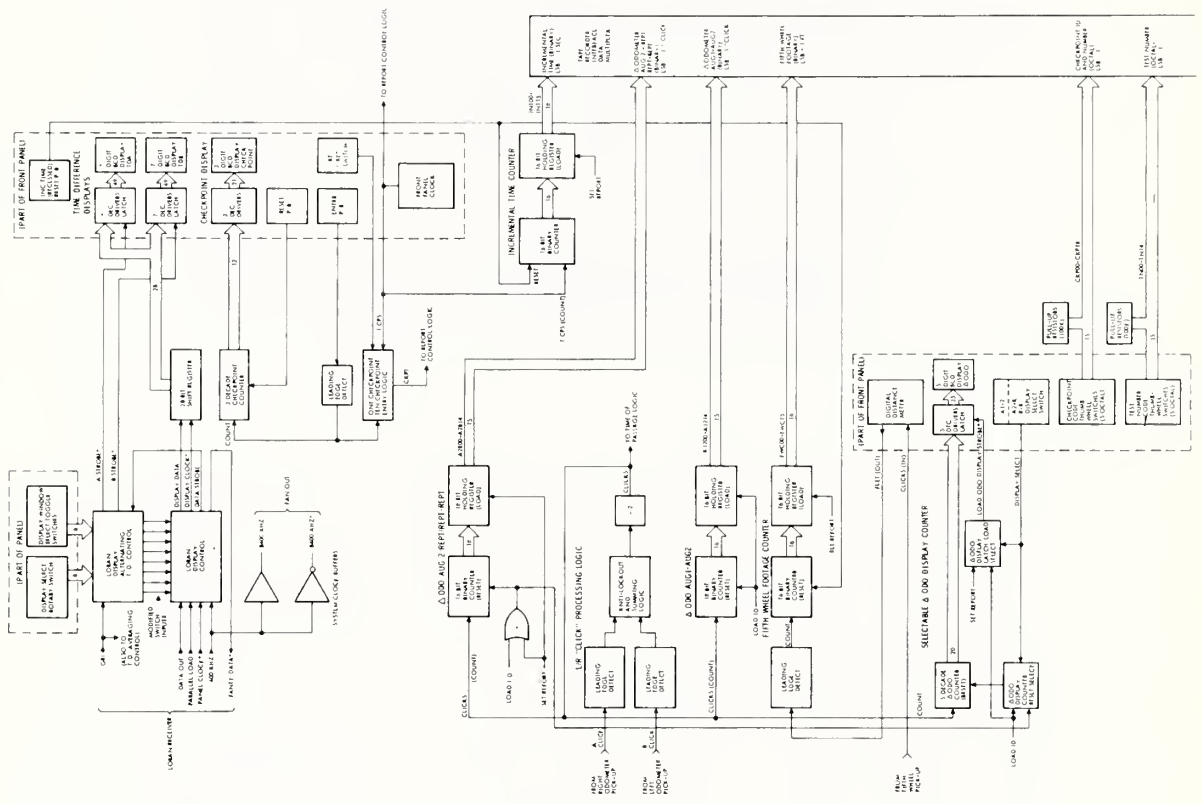
Figure 3-9. AVM Test Console
Block Diagram

- a. It allowed the test operator to input data such as checkpoint number, test number, and checkpoint arrive.
 - b. It displayed all sensor outputs such as LORAN time difference, augmentor ID, and odometer.
 - c. It collected all the sensor data, formatted it along with other relevant information such as equipment status and incremental time and presented it to the tape recorder along with the appropriate "write" commands. A brief description of its displays and controls follows. See Figure 3-9.
1. "TD1" and "TD2" are the two time difference displays. Each display presents the latest TD measurement from the Microlocator, in its entirety, i.e., 16,254.62 (microseconds). Note that this is essentially 'raw' TD data (not averaged) and slightly

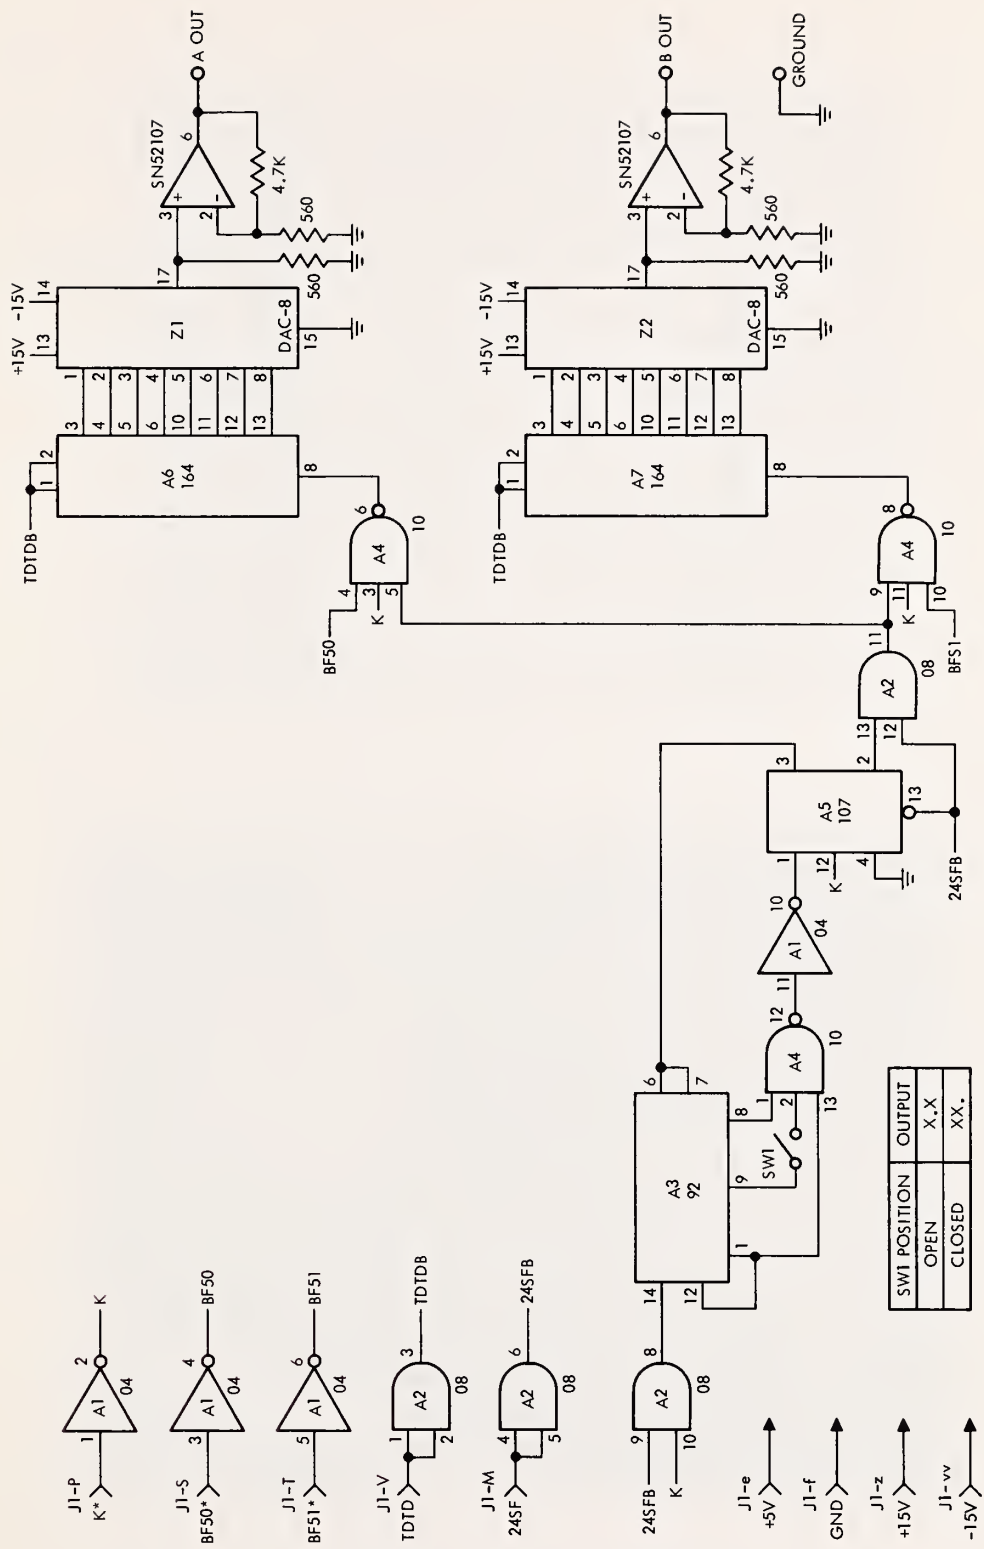
Figure 3-10. Monitor Recorder Interface

The monitor station consisted of a LORAN receiver, ACU, strip chart recorder and interface. This equipment operated continually during the calibration and test process. No significant time difference deviations which could affect location measurements were noted. In particular, the ministration exhibited remarkably stable timing characteristics throughout the Phase I program.

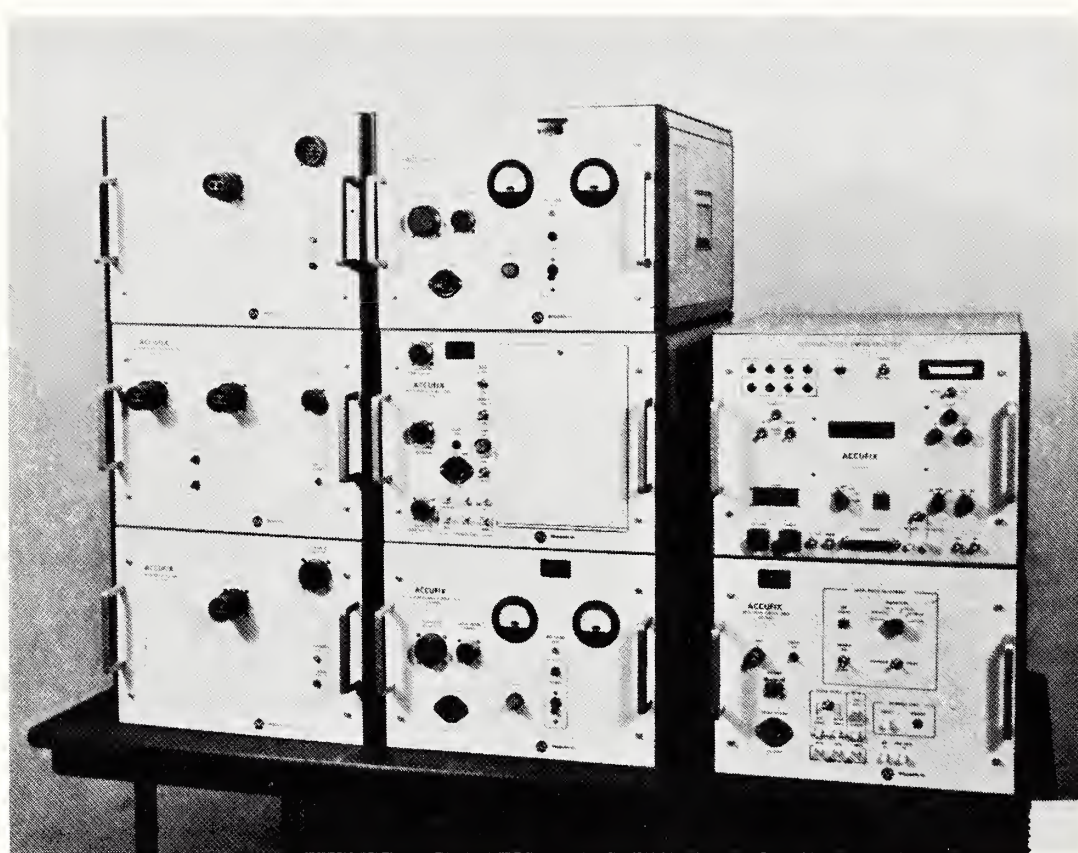
Figure 3-12. LORAN C Mini Station

A LORAN C ministration was temporarily installed in Limerick Township, PA, for the duration of the Phase I Program. Standard LORAN C coverage in the Philadelphia area has been shown to be inadequate in view of the location accuracy required. In particular, the LORAN C Slave at Dana, Indiana, does not provide the test area with signals of sufficient strength and quality required to meet the objectives. The ministration was assigned a coding delay of 82,000 microseconds by the U.S. Coast Guard and authorized to transmit at a nominal radiated power

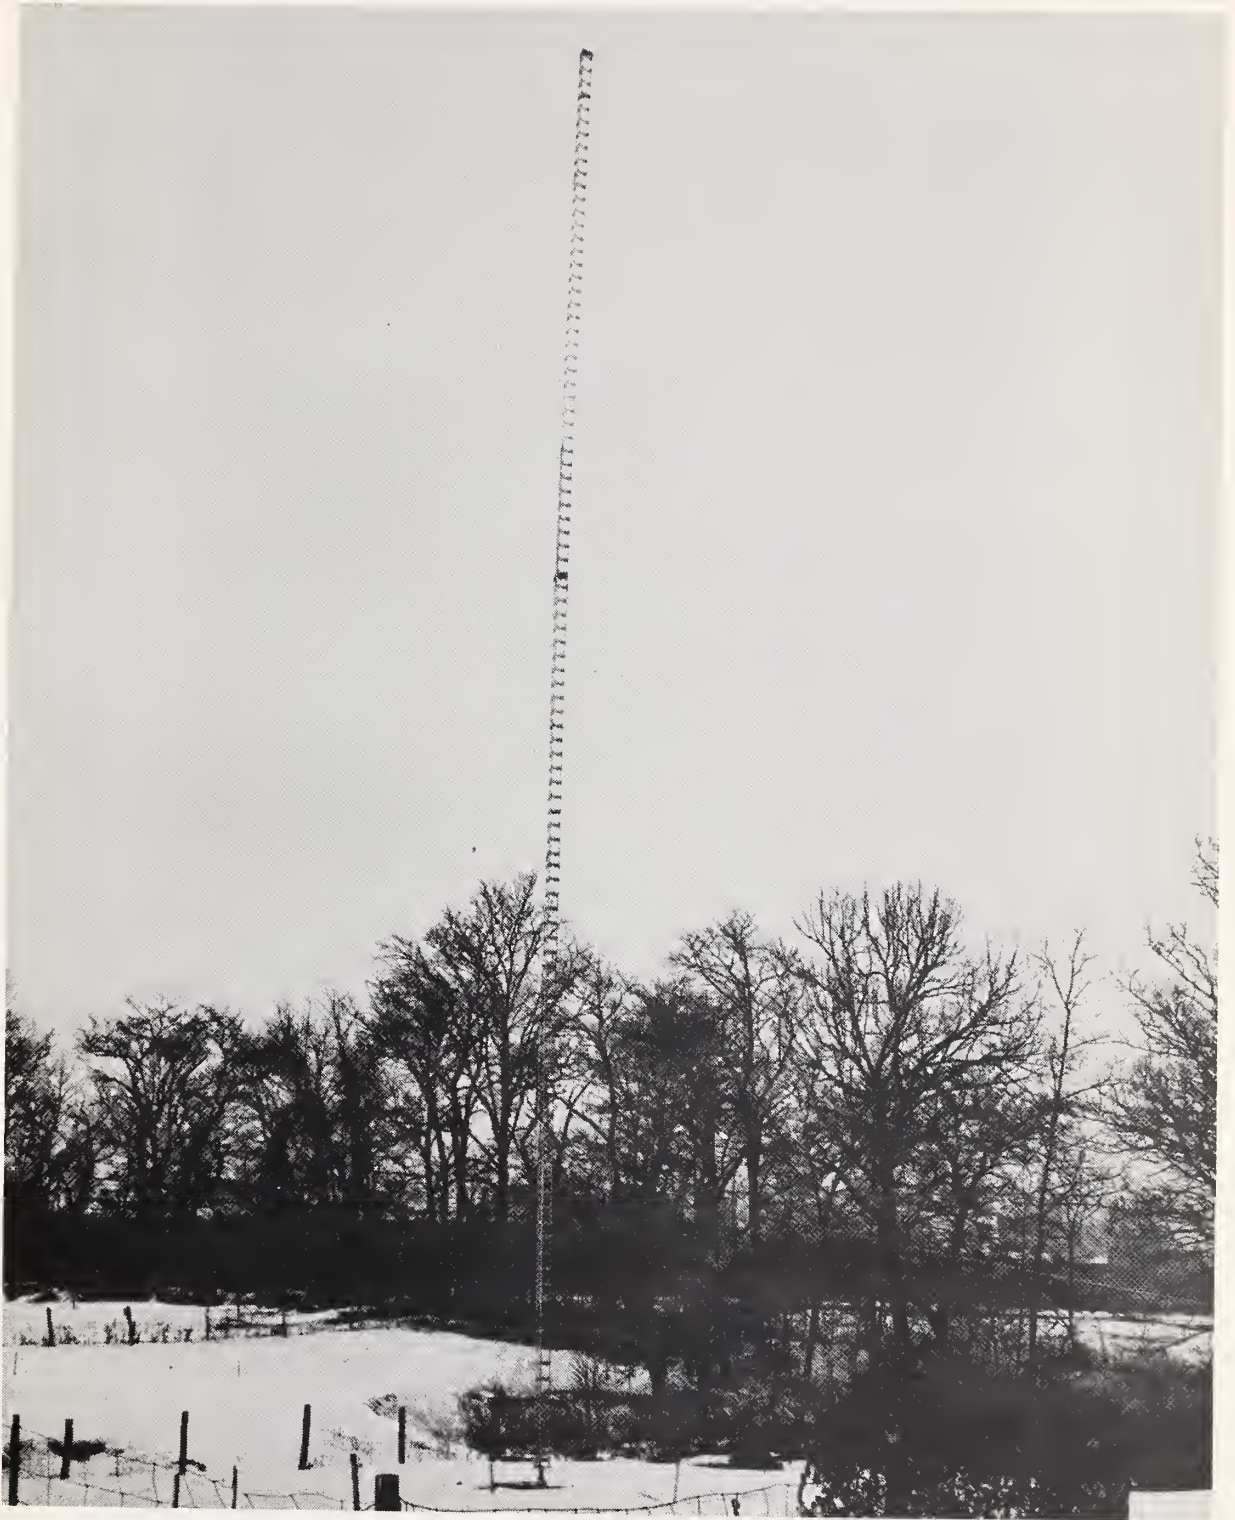
Figure 3-14. Tower Installation

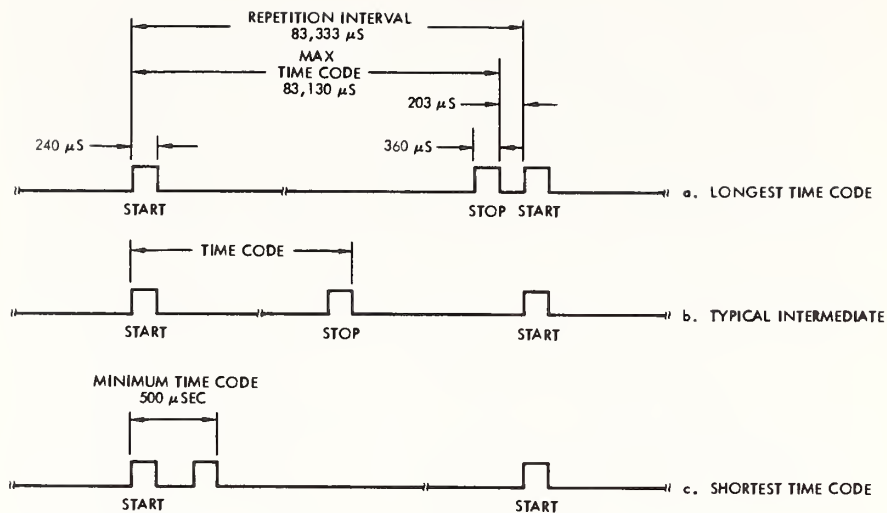
Figure 3-19. Augmentor Timing Code

The code specified in the code generation is in the form of a time period between pulses rather than the more conventional binary or BCD number transmission. This simplifies vehicle and augmentor hardware and increases reliability. Figure 3-19 is a timing diagram of the coding technique used. Detection of an augmentor signal consists of recognition of the 240-microsecond start-pulse and the 360-microsecond stop-pulse. The time between these pulses must be within a predetermined limit or no detection is made. Any combination of signals which meet this criteria will constitute an augmentor detection, while the time from

start-pulse falling edge to stop-pulse falling edge will uniquely identify an augmentor. Noise which occurs between pulses has no effect unless it occurs after the start pulse and causes the receiver to produce an artificial pulse exactly 360 microseconds long.
